## DEVELOPMENT of ADVANCED INSPECTION DEVICE for INSIDE CONCRETE STRUCTURES

**KEYWORDS:** local destructive test, drilled hole, stick scanner, image analysis, plural information

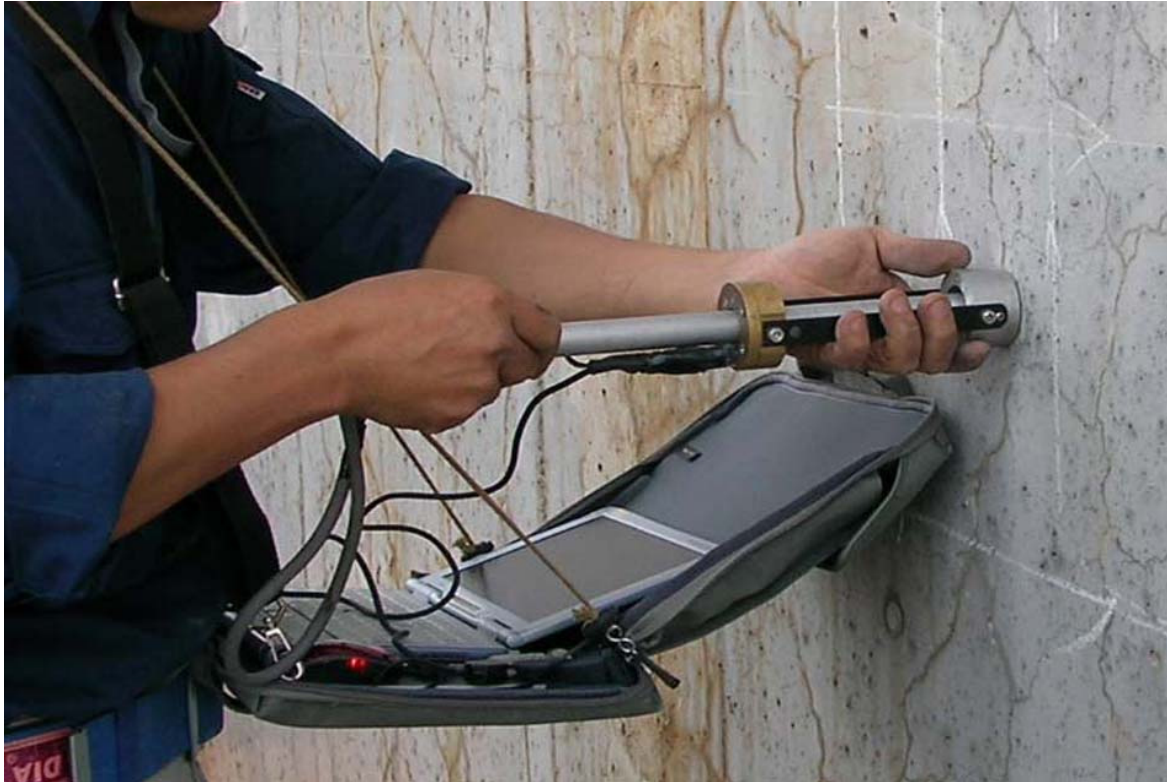
**Figure 4. Scanning operation**

In the first stage, a reinforcing bar investigation is performed by steel bar detector to determine a drilling location. Inspection procedure with this scanner, from reinforcing bar investigation to the segment restoration, is shown in **Figure 3**. The actual scanning operation is shown in **Figure 4**, and the stick scanner will turn on manually by hand operation. The image of inside concrete drilled hole is displayed on notebook PC monitor by real time.

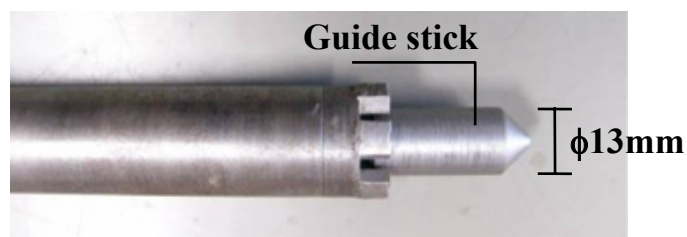
**Figure 5. Diamond drill bit**

For the core drilled method, a preliminary hole with the diameter of 14.5mm was drilled by hammering drill bit, and next to hole with the diameter of 24.5mm was over cored by the diamond drill bit that installed a guide stick as shown in **Figure 5**. The purpose of preliminary hole is to make up for the deficit of current reinforcing bar investigation limit. The accuracy of this investigation more than 100mm of depth is low, so that guide stick with diameter of 13mm will be able to confirm the existence of steel reinforcing bar before over coring. The diamond drill bit using in this method will improve the accuracy of circle and straightness of drilled hole. There are many preliminary processes in this method, but on the other hand there are many advantages too, such as the working time reduction (about 30 minutes), the damage degree minimization, and no danger to cut off steel reinforcing bar comparing with conventional coring method.

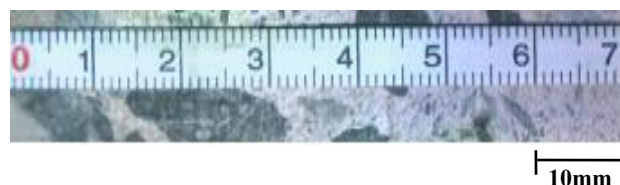
**Figure 7. Scanning image confirmation**

Distance from object to the contact image sensor in this scanner is one dimensional in consistency. It means an image pixel always becomes the same size with scanner reading resolution. One pixel in image becomes  $84.7\mu\text{m}$  for reading resolution setting of 300dpi. It is verified with theoretical value as affixed scale as shown in **Figure 7** for confirming the scanning image. Scale calibration by various measurements with digital camera became unnecessary with this scanner, and the distance between two arbitrary points in image can be easily measured from the pixels number.
