DEBONDING BEHAVIOR OF GFRP SHEET REINFORCED CONCRETE

(BM-136)

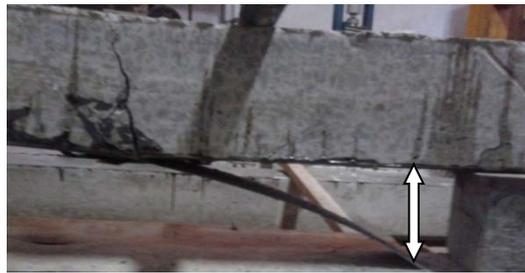
Figure 1 Debonding failure of GFRP sheet on a concrete beam

mode. Figure 1 shows a debonding of GFRP sheet on concrete beam. A good understanding of the bond behavior between the FRP plate and the substrate

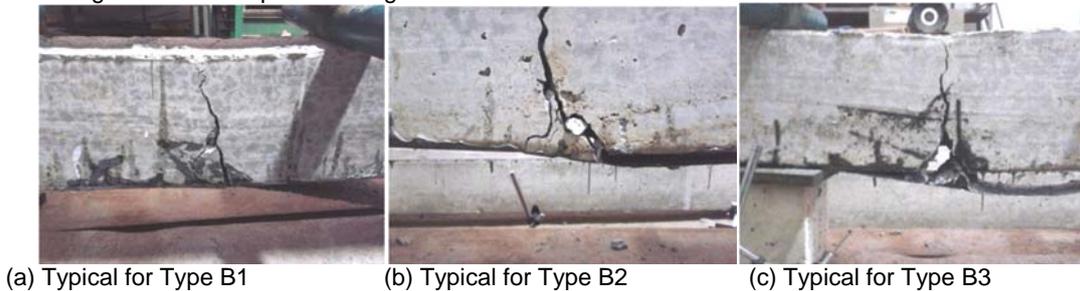
Figure 8 Typical major cracks of specimens
