# A NEW RETROFIT TECHNIQUE TO IMPROVE SEISMIC RESISTANCE OF MASONRY WALLS UNDER OUT-OF-PLANE LOADS

(SC-057)

## ABSTRACT

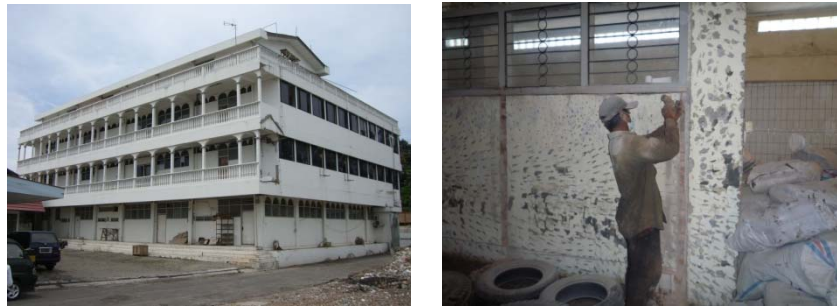
Photo 1. Earthquake-damaged building and brick walls for test

The proposed strengthening method was applied to brick wall specimens which were extracted from an earthquake-damaged building in Indonesia [3], as shown in Photo 1.
